FCT SERVICE NOTE SN06071117a

Subject: VCT Detector Routing Board Connection Inspection & Troubleshooting Details (For 2006 style Plenum)

Effectivity: VCT (7.x systems, 32 and 64 Slice)

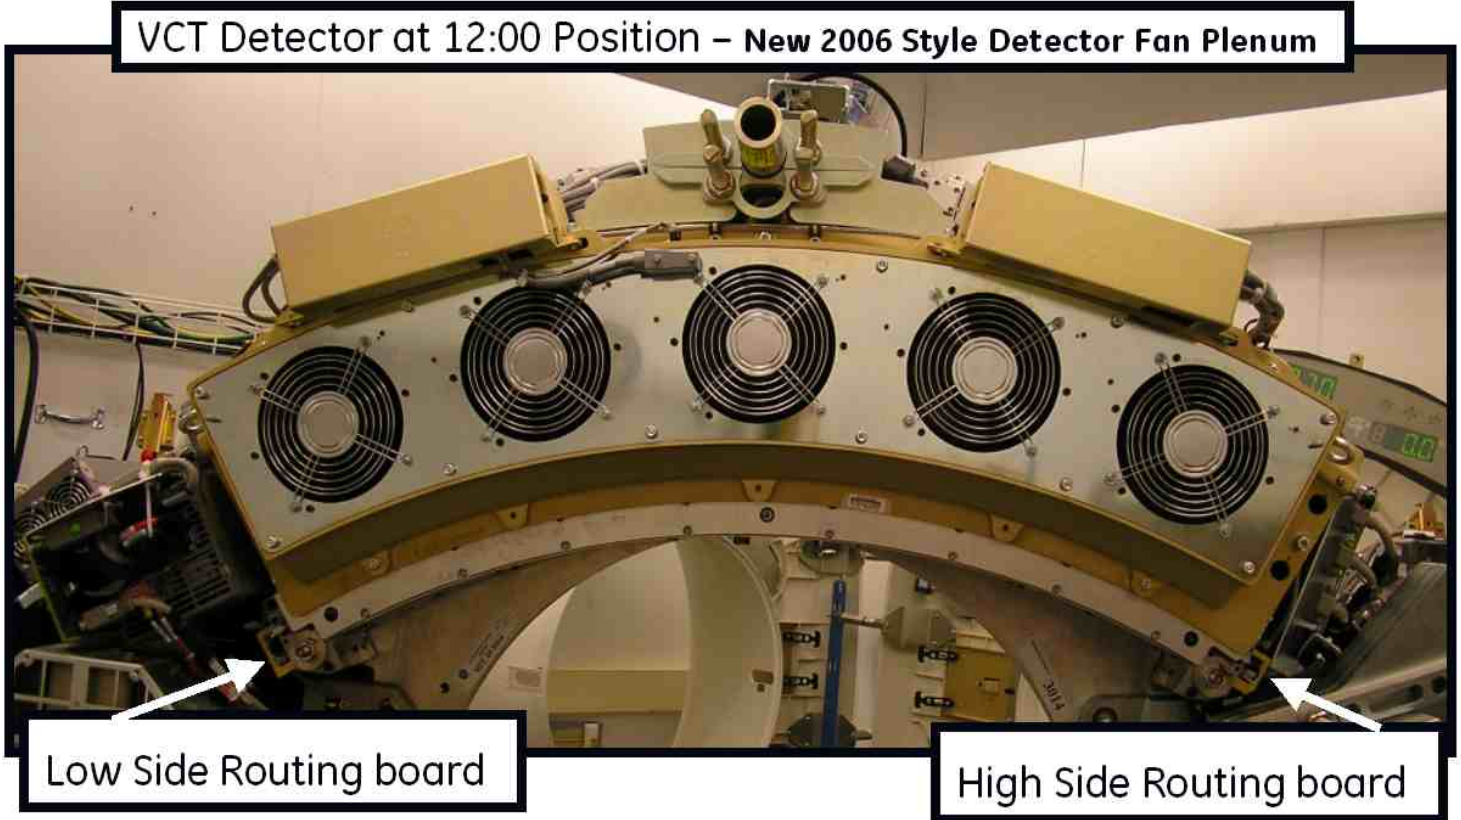
Figure 1 - VCT 64 Detector Full View

A leading cause of the above error message is a loose J2 connection at the Low or High side Detector Routing boards, see **Figure 1**. Primarily this issue is seen on the Low side Routing board but a loose connection could also be seen on the High Side Routing board J2 connection. The failure mode seen recently on installs has the J2 connection opening up which simulates the Open thermostat.

- 1) **Effective until October 1st, 2006: On every install, perform a Visual inspection of the Routing Board J2 connection, following the steps detailed in Section 1.**
- 2) **If Trouble Shooting is required for a Cold Detector issue follow the steps detailed in Section 2.**

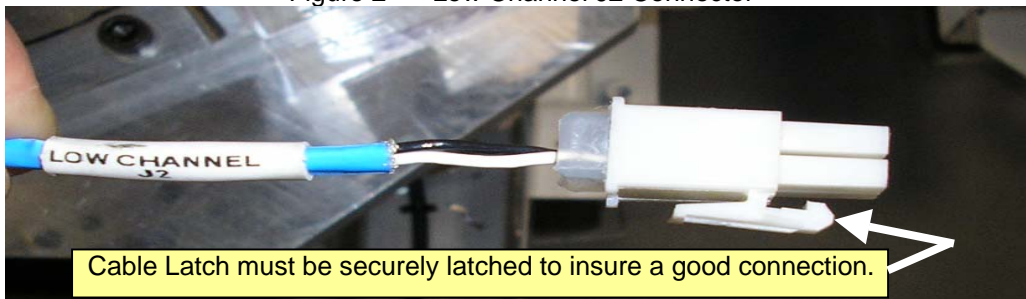
Figure 2 - Low Channel J2 Connector

- 1) Check to make sure the J2 connector is physically latched into place, see **Figure 2, 3, 4, 5 & 6** for details.
- 2) Check for any connector discoloration, a yellow/brown color could indicate a problem, the use of a small mirror may be helpful. See figure 7 for example of discoloration.

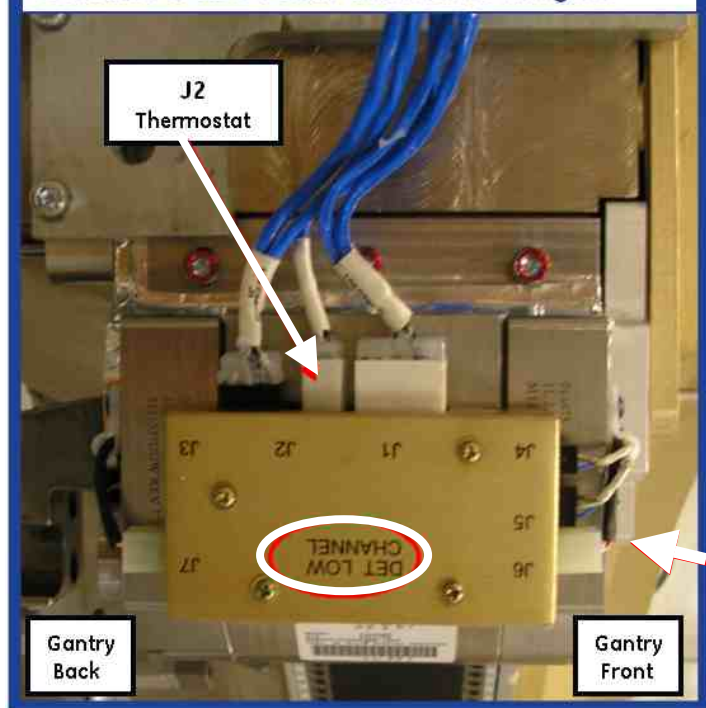
Figure 5 - LOW CHANNEL SIDE

LINE OF SIGHT TO J2
 Using a flash light verify the Molex connector Latch is in place. The Latch is shown in Figure 2 – Mate-n-Lok Molex Connector.

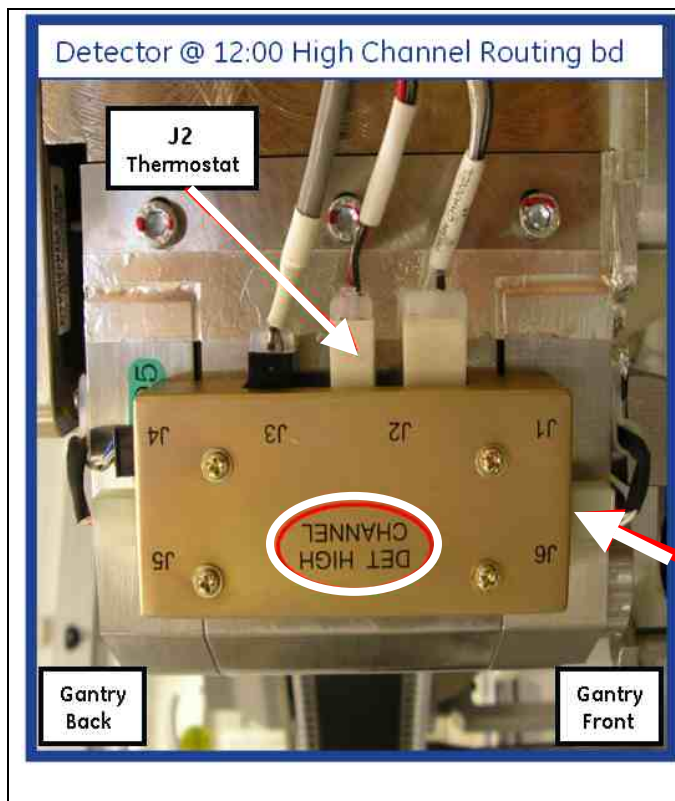
Figure 6 - HIGH CHANNEL SIDE

Using a flash light you can verify the Molex connector Latch is in place. The Latch is shown in Figure 2 – Mate-n-Lok Molex connector.

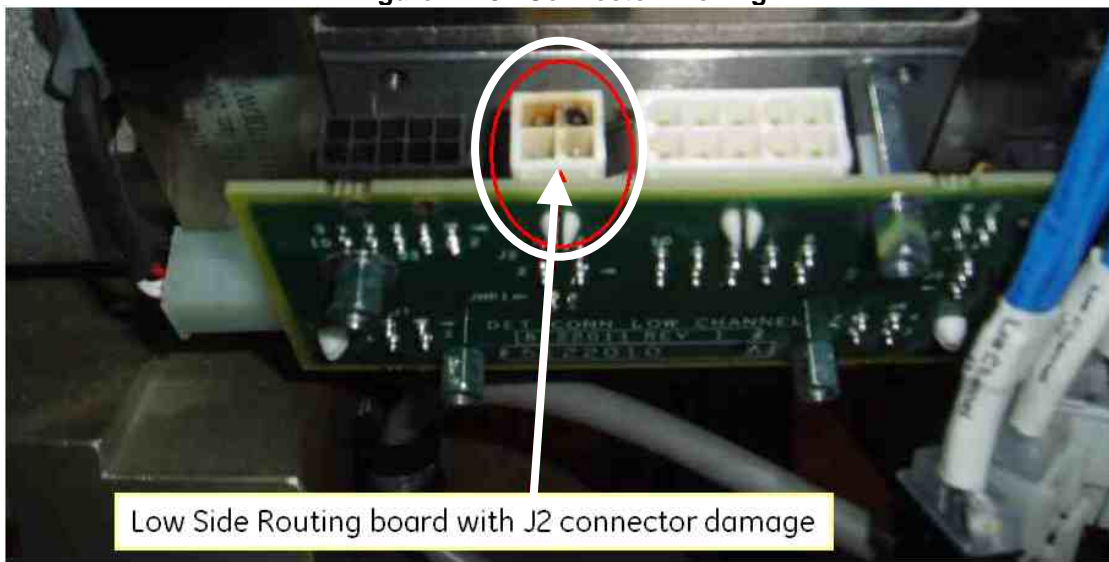
Figure 7 - J2 Connector Arching

- 1) Turn off power to gantry
- 2) Pull DHC (Detector Heater Control) board connector J1 and measure between pins 1 and 14. This should measure a short (approximately Zero ohms) for the Low Channel Routing board. A higher resistance indicates potential arcing has occurred.
- 3) Measure DHC J1 between pins 4 and 17. This should also measure a short (approximately Zero ohms) for the High Channel Routing board. A higher resistance indicates potential arcing has occurred.

If a High resistance is measured, check the J2 connection on the routing board showing a high resistance. See Figure 7 for example of connector damage. If this is seen replace the Routing Harness and Routing board, see service note SN-06051009A for part numbers.

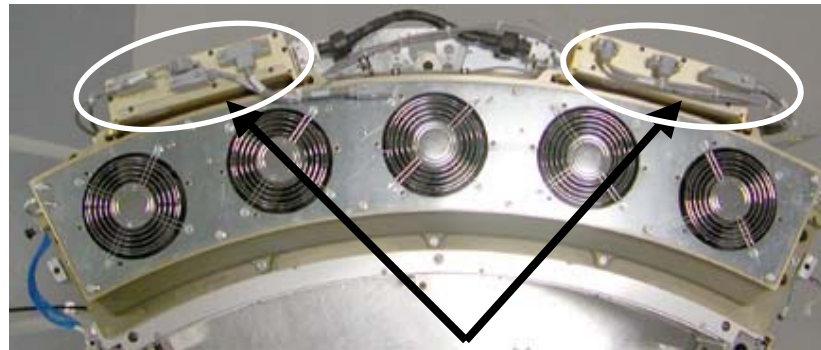
VCT Detector Heater Control (2006 Style)

Low side left routing board (input side):
 J1 Pin 1,3 is 50-62 ohm (DHC J1 Pins 9,10)
 J1 Pin 2,4 is 20-24 ohm (DHC J1 Pins 11,13)
Low side left routing board (Output side):
 J7 Pin 1,3 is about 27 ohm (Left Rear)
 J6 Pin 1,3 is about 27 ohm (Left Front)
 J7 Pin 2 to J6 Pin 2 is 20-24 ohm (Center)
 Must have high side board connected to read center zones.

High side right routing board (input side):
 J1 Pin 1,2 is 50-62 ohm (DHC J1 Pins 7,8)
High side right routing board (output side):
 J6 Pin 1,3 is about 27 ohm (Right Rear)
 J5 Pin 1,3 is about 27 ohm (Right Front)
