GE Medical Systems

**Direction 2319693
Revision 0**

Signa® Gradient Radial Support Upgrade

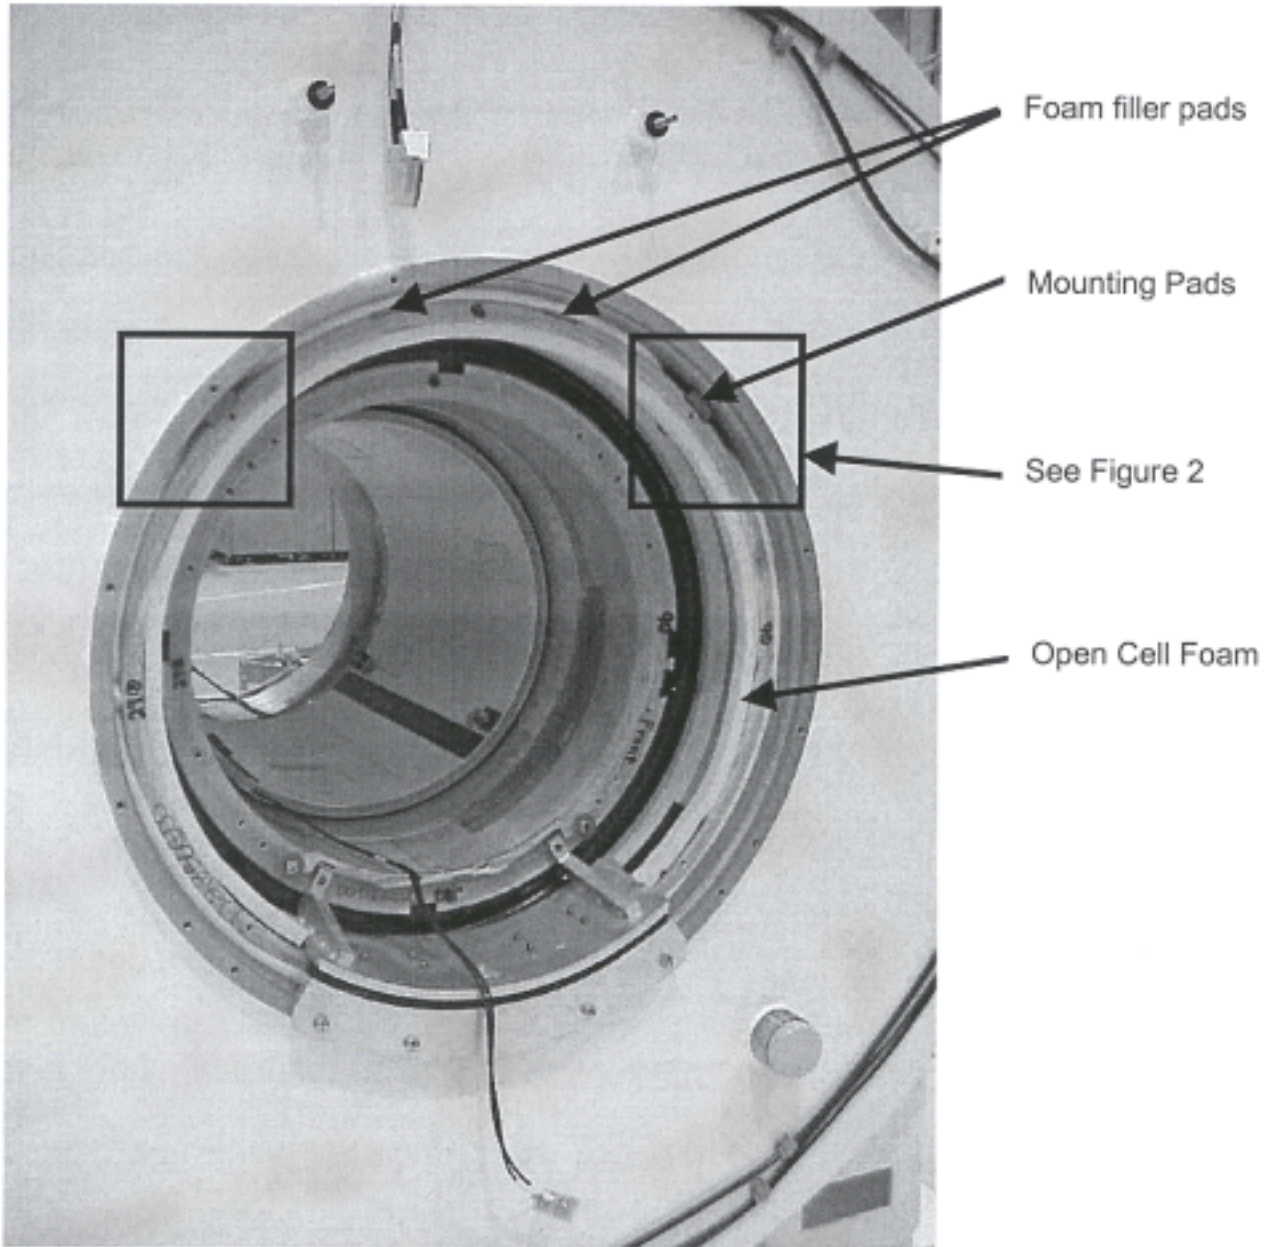
ILLUSTRATION 1
OPEN MAGNET

All Signa systems with BRM or CRM in a Cx/K4 (LCC) Magnets, GE S Series Magnets, GE Cx Magnets and Oxford magnets. The purpose of this upgrade is to prevent excessive gradient coil motion, which can result in image quality issue such as DW-EPI pixel voids.

3. Install foam filler pad (2181231-2) in the 1 o'clock and 11 o'clock outer gradient coil slots as shown in Illustration 1. The filler pads are to prevent airflow.
4. Insert the cell foam (2174929-9) between the gradient and magnet bore, overlapping the remaining rubber cord at the bottom to form a good air seal. Trim as needed.
5. Refer to Illustration 2, 3 or 4 depending on your magnet, Install M16 allen head set screw (2293535) in the 10 o'clock and 2 o'clock positions.
