TROUBLESHOOTING GUIDANCE FOR 16BEAT - HNU COIL

HNU Coil Failure modes identified from SV16 systems :

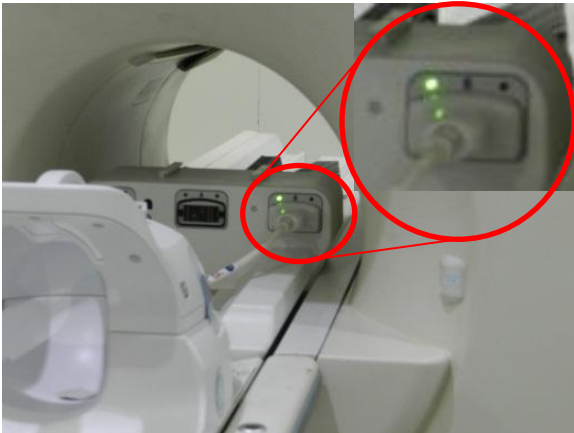
- when the coil side connector is connected into LPCA, RED and GREEN LEDs glow simultaneously at first. Within a few seconds, the RED LED will turn off and GREEN LED glows consistently as long as there is no change in coil configuration and the coil is kept connected to LPCA coil.

Ideal case

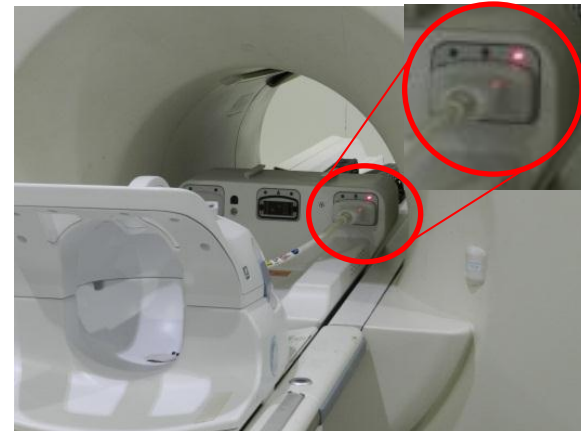
- GREEN and RED LEDs glow simultaneously at first, when the coil is connected. Within a few seconds, GREEN LED turns OFF and RED LED glows consistently.
- No LED glows at all when the coil is connected to the system.

Coil ID Failure Case

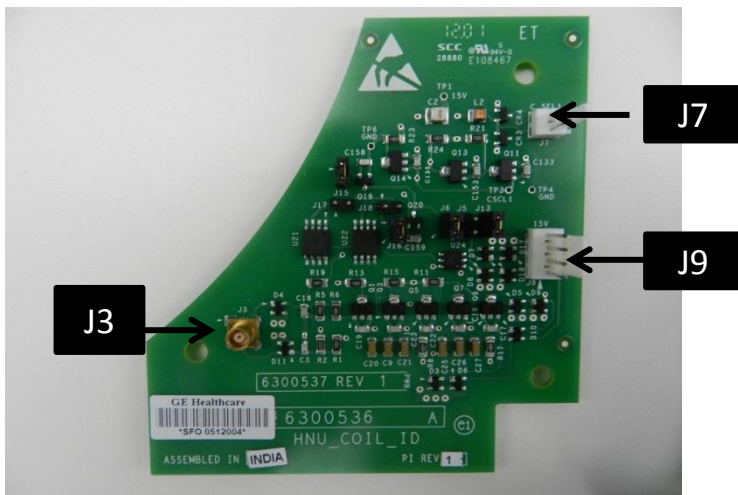
Connectors on the coil ID board

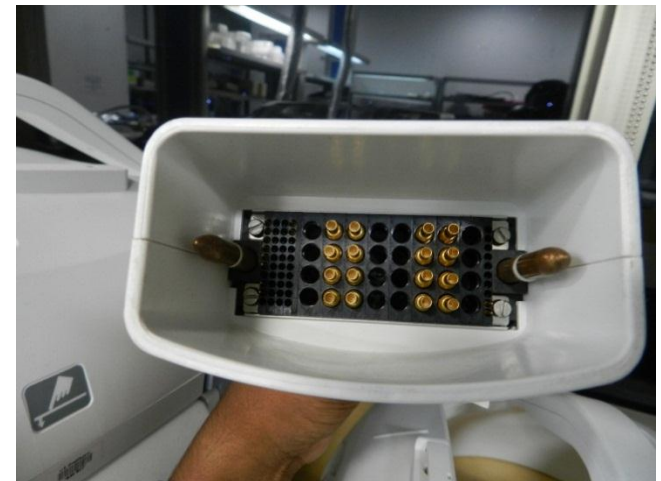
Normal Hypertronics connector

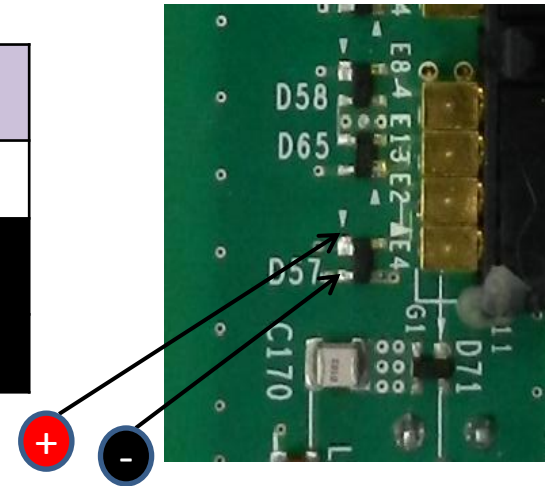
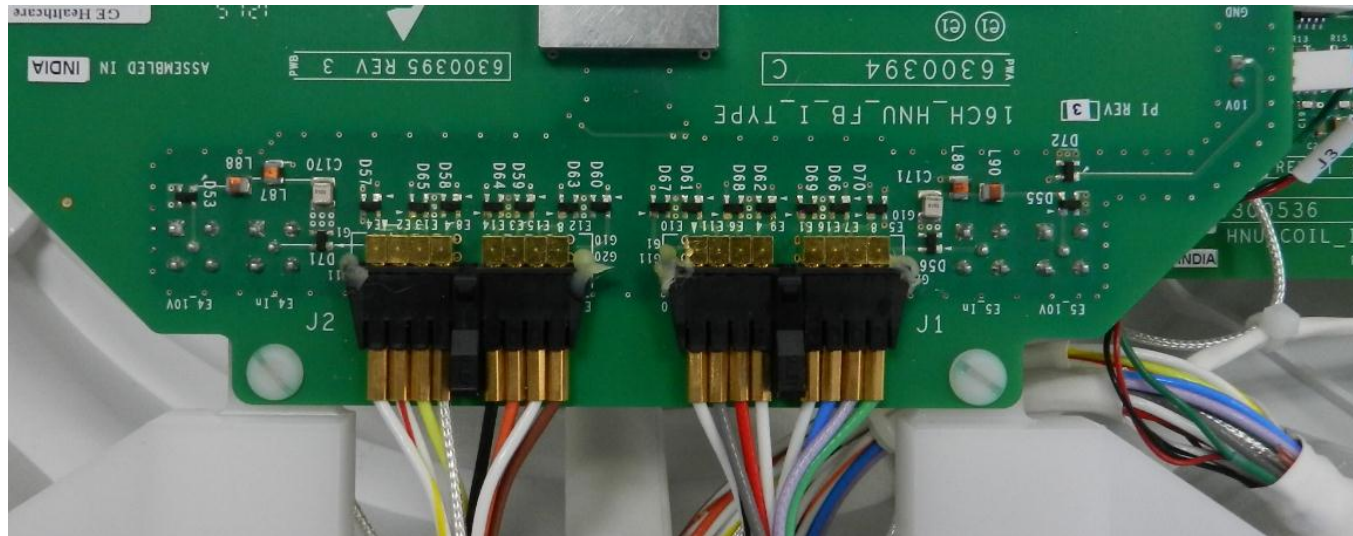
Diode check: Remove the coil from MR system and then place anterior on the posterior. Perform diode check across the 2 pins for diodes. Ideal values (in volts) are as follows:

In case any of the channel readings observed are different from the Ideal values as given in the above table, then that channel is faulty .

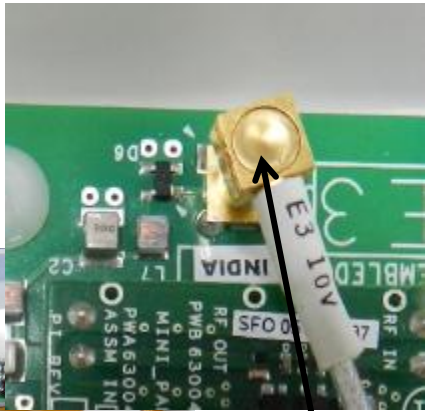
PCX connector

All Connectors shown shall be re-seated

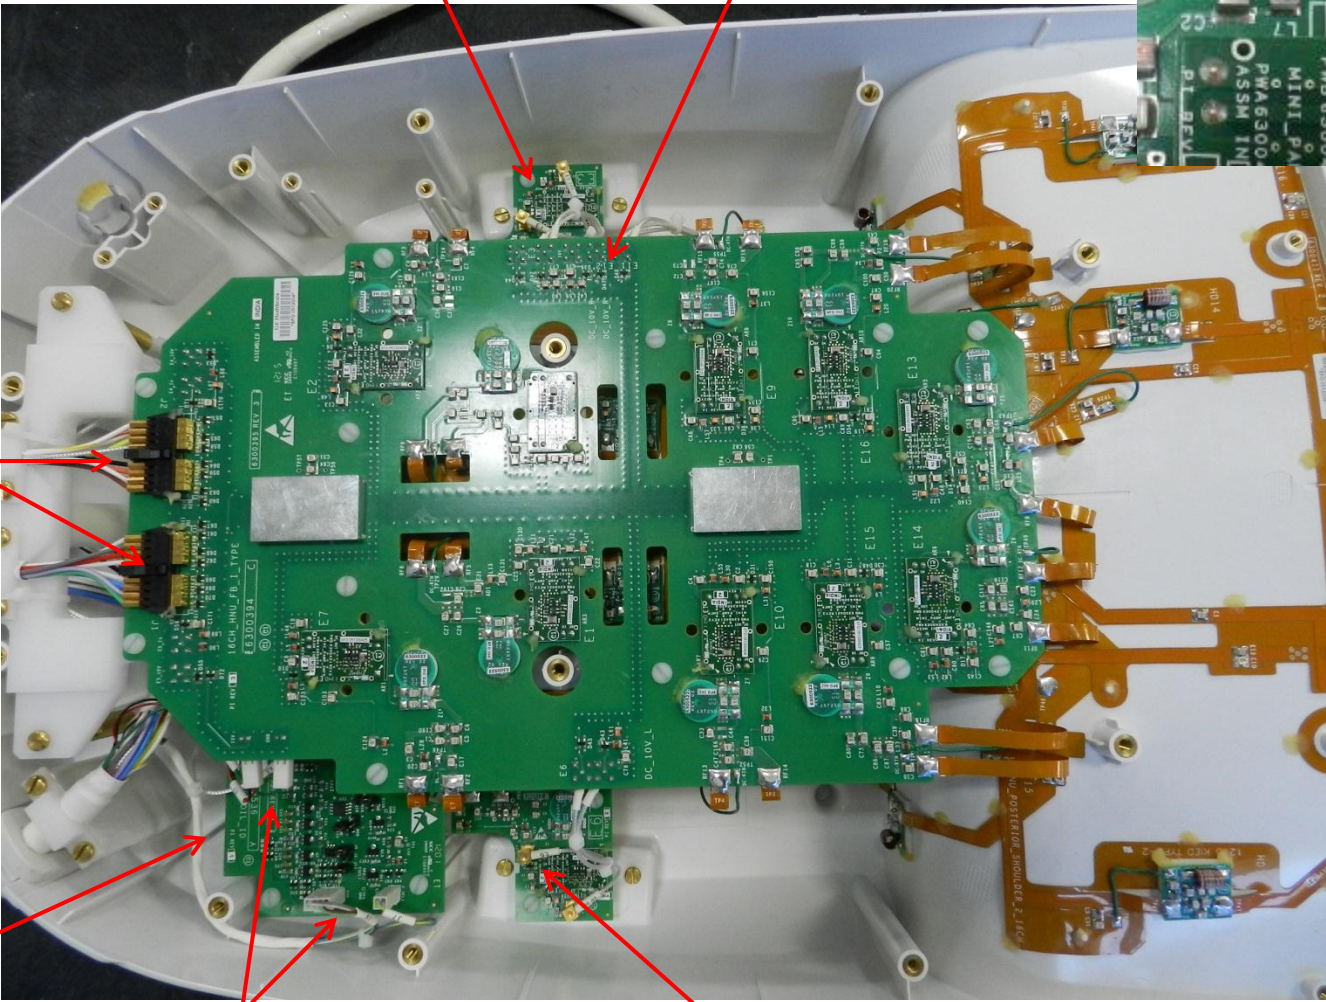
2 MOLEX connectors

1 PCX connector on coil id

4 DC connectors

4 PCX connectors
