Merc40 Power distribution and monitoring

Troubleshooting guide

H. Miyajima
Hino CT Eng.

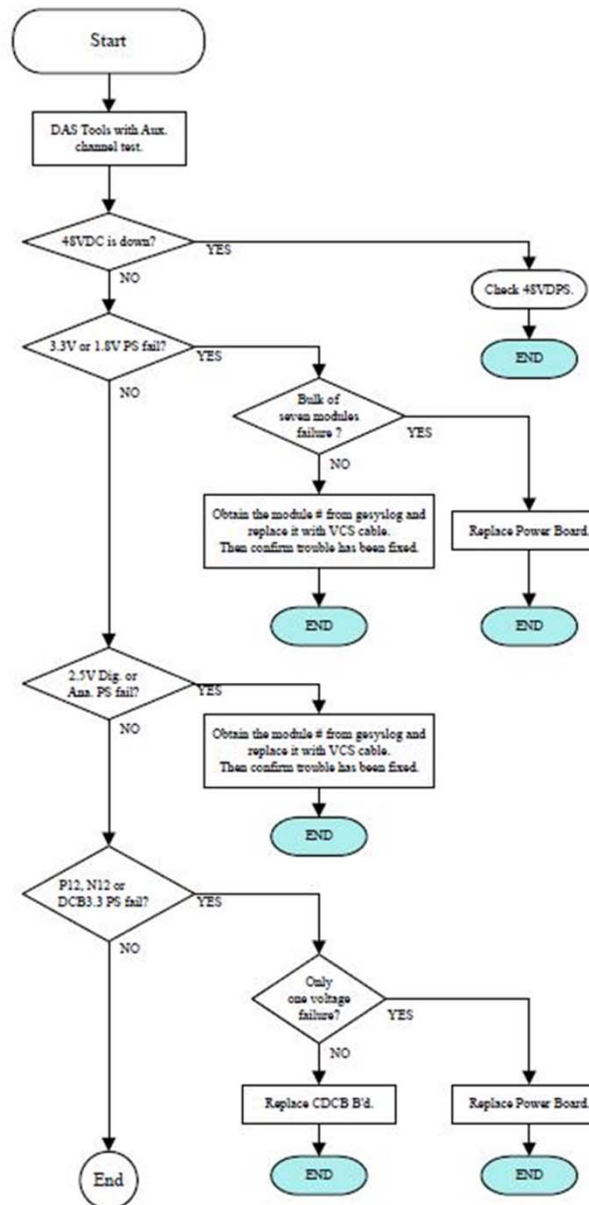
Power failure
Isolation flowchart.

Power Board (PB) Failure Isolation.

If failure found on 2.5V Digital or 2.5V Analog, PB is normal. Focus on module # in `ssw.dastools.hist`

If failure found on 3.3V or 1.8V, check if the error is found multiple module or single module. If single, focus on module# in .hist.

If multiple, check if the modules are block of 1~7, 8~15, 16~21 or 22~27. If so, PB is defective.

If error is found on P12, N12 or DCB3.3, PB is defective. If all of them are out of spec., check 48VDC power cable connector or CDCB connector to Back plane.
