GE Medical Systems

**Direction 2271344
Revision 8**

RTIP For AW3.1 & 4.0 Service Manual

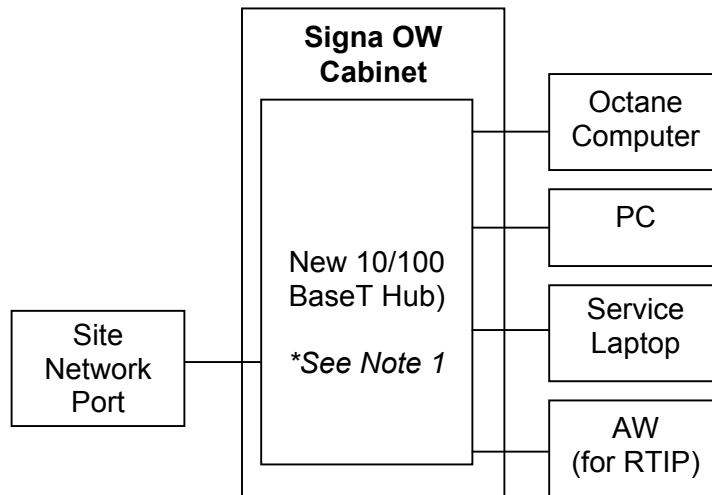
AW WITH RTIP CONNECTION - PREFERRED METHOD
ILLUSTRATION 2-1

Note 1: To ensure that the RTIP application runs correctly, no workstations except the AW used for RTIP can be connected to the 10/100BaseT Network Hub.

The AW that you will load RTIP on must be connected to Signa using the preferred method (see Illustration 2-1) or the alternate method (see Illustration 2-2).

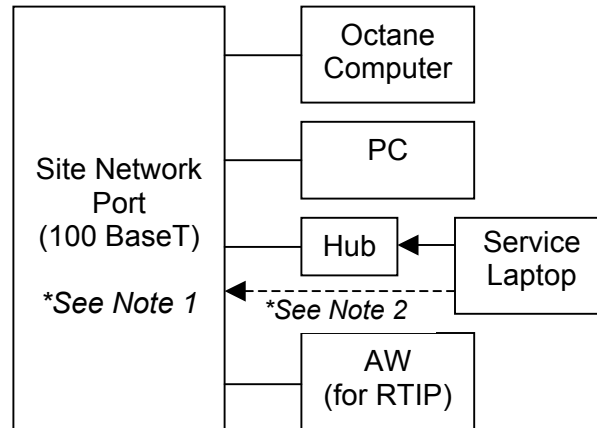
AW WITH RTIP CONNECTION - ALTERNATE METHOD
ILLUSTRATION 2-2

Note 1: Site port must be minimum 100 BaseT switch/network device (not a router or repeater) that provides 100% of bandwidth at all times between the Octane computer and the AW used for RTIP applications.

Note 2: Optional path (used if hub cascading limits are reached).

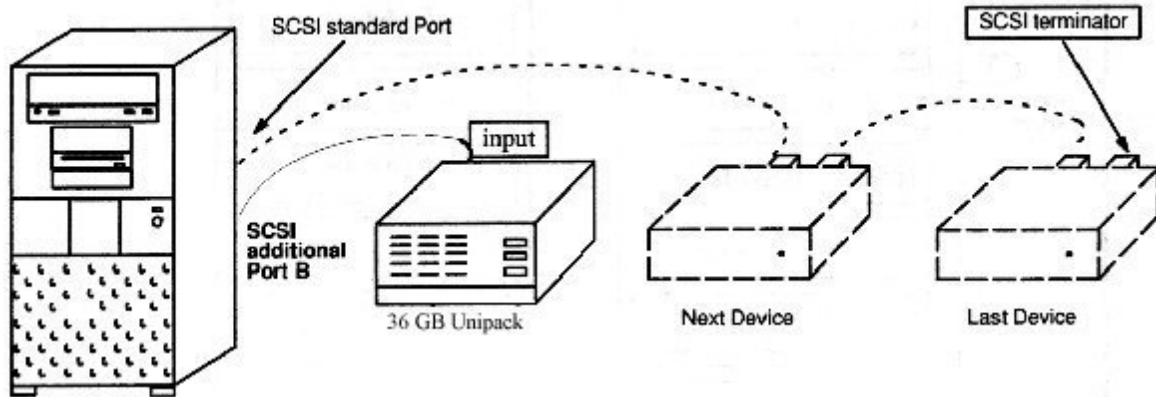
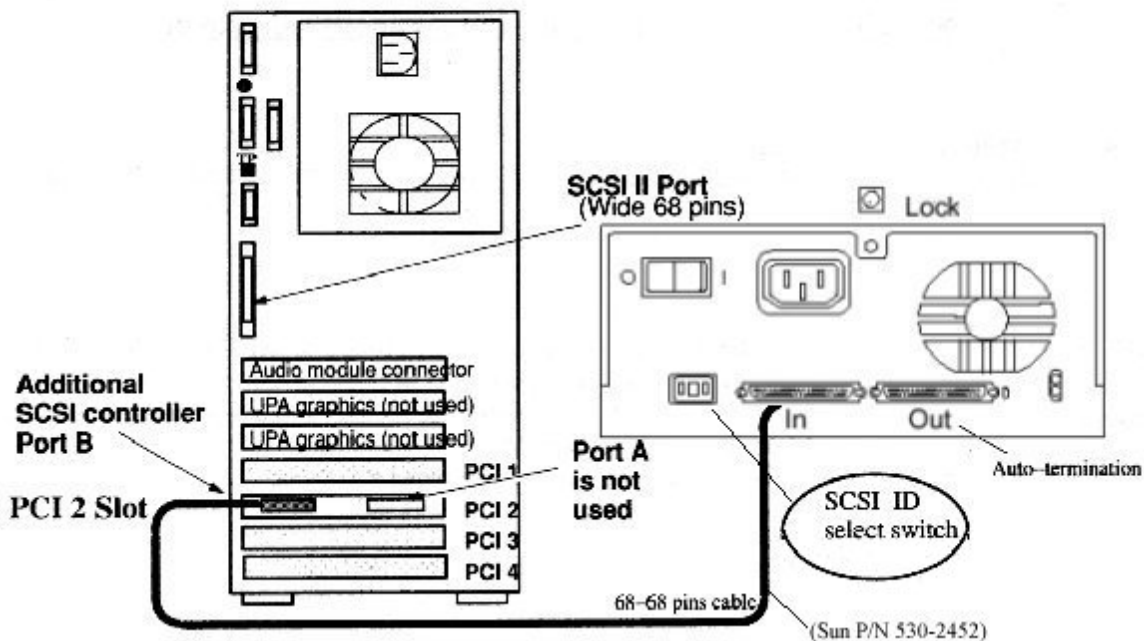
RTIP CONNECTION - ULTRA 60
ILLUSTRATION 2-3

Rear view connection

1. **New AW:** The Ultra 60 AW requires an additional SCSI controller for RTIP. If RTIP is ordered with a new AW workstation, the second SCSI controller (PCI Board) should be already installed in PCI-2 slot. Connect the 36GB Unipack Storage disk for RTIP images to the PCI Board per Illustration 2-3.

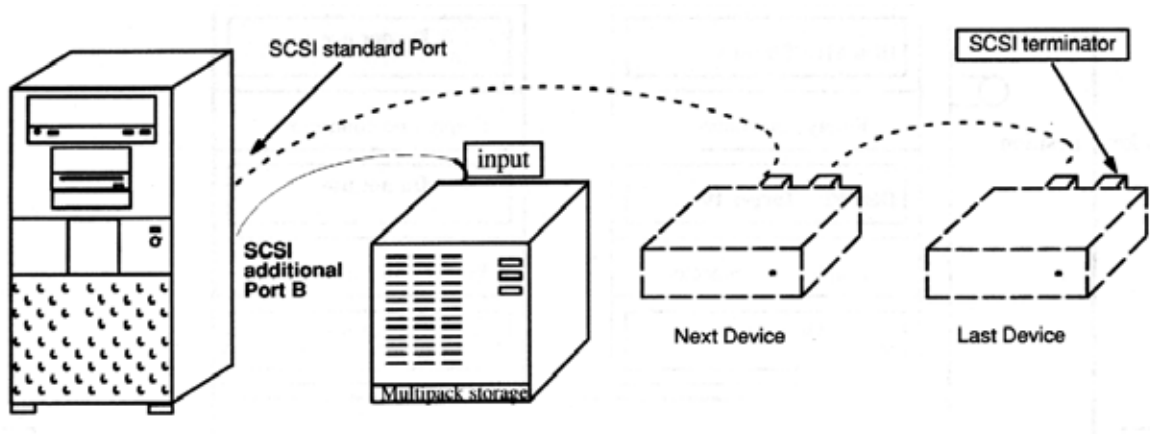
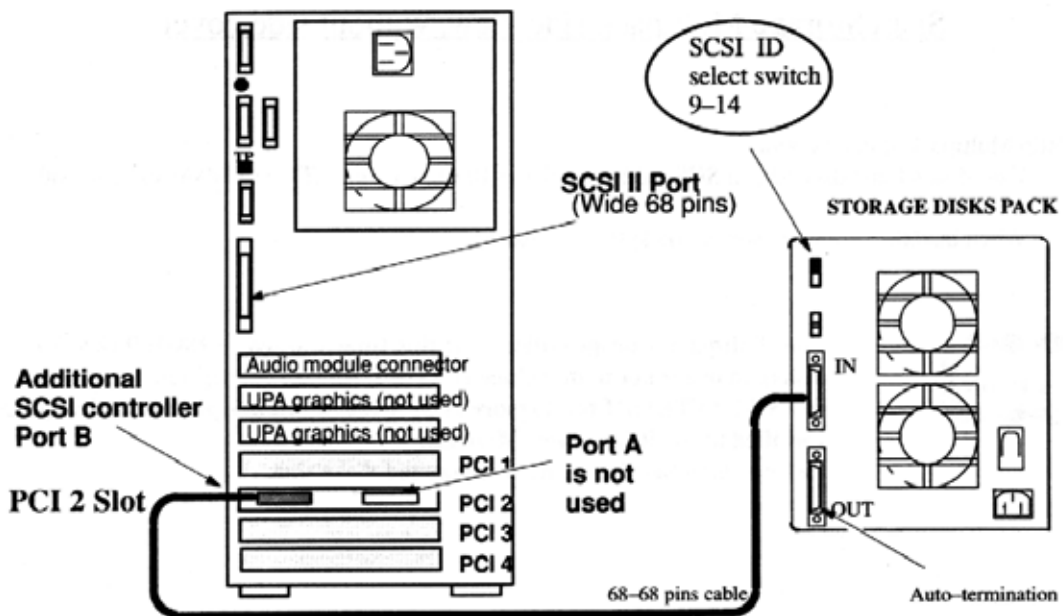
RTIP CONNECTION - ULTRA 60
ILLUSTRATION 2-3

The 2271261-2 version RTIP for AW3.1 & 4.0 CD-ROM will not install on an AW4.0 Ultra 60 with the PCI Board (2nd SCSI board) installed in PCI 2 slot (controller ports c3 & c4). The -2 RTIP software will only install with the PCI Board in PCI 1 slot (controller c1 or c2). If installing RTIP for AW3.1 & 4.0 using the -2 version CD-ROM on an AW4.0, move the PCI Board from PCI 2 slot to **PCI 1 slot**. If you receive the updated -3 or later version RTIP CD-ROM this problem is fixed, so the PCI Board should be installed in slot PCI 2.

Rear view connection

- a. Shut down the AW.
- b. Turn OFF the power to the AW.
- c. Install the PCI Board in **PCI 2** slot if using **-3** version RTIP CD-ROM. Install the PCI Board in **PCI 1** slot if using **-2** version RTIP CD-ROM. Refer to 2243431-100, Sun UltraSparc 60 Service Manual, Section 10.3.2 "Replacing a PCI card". (The SCSI controller board is referred to as the "PCI card".)
- d. After installing the second SCSI controller board, connect the Multipack Storage Disks tower to it per Illustration 2-3.

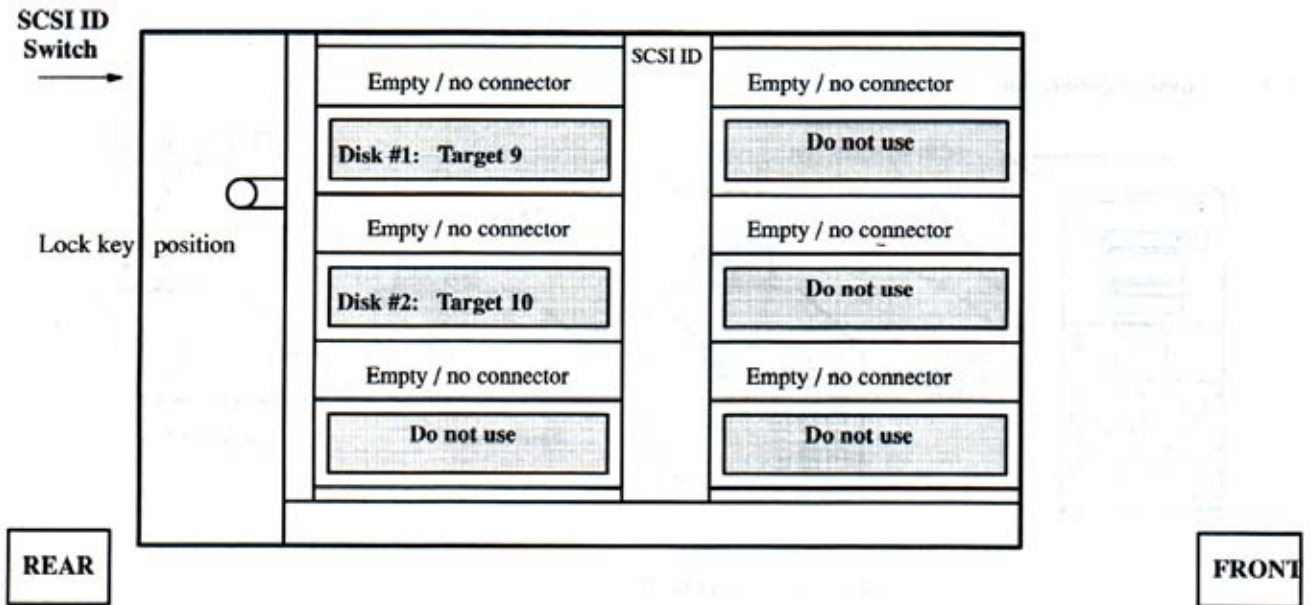
18GB MULTIPACK STORAGE DISKS TOWER (SIDE VIEW) –
REQUIRED DRIVE LOCATIONS FOR RTIP WITH ULTRA 60
ILLUSTRATION 2-4

- Verify the “SCSI Switch” on the back of the tower is set to the “9-14” (up position). (The disk drives remain in SCSI slots labeled 1 and 2. With the “SCSI switch” in the “9-14” position, the disk SCSI IDs are set to 9 and 10.) See Illustration 2-4.

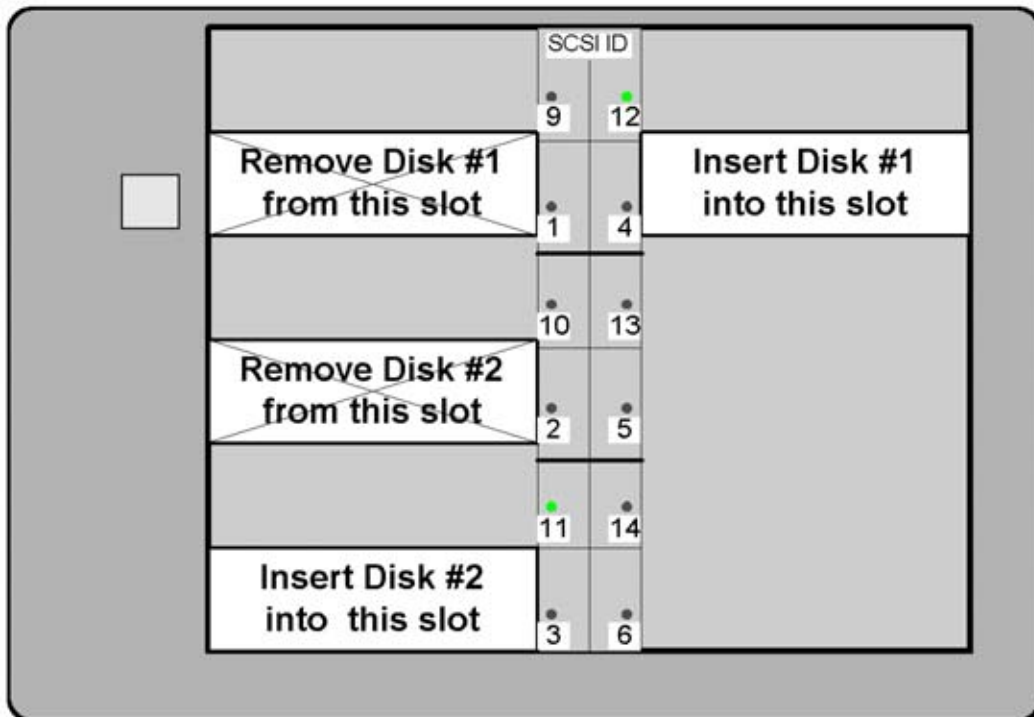
18GB MULTIPACK STORAGE DISKS TOWER (SIDE VIEW) –
REQUIRED DRIVE LOCATIONS FOR RTIP WITH ULTRA 2
ILLUSTRATION 2-3

The first number for each slot is the high SCSI ID for that slot, i.e., the ID when the SCSI ID switch on the rear panel is set to "9-14". The second number is the low SCSI ID, i.e., the ID when the SCSI ID switch is set to "1-6". (For example, slot 9/1 is the slot having 9 as the upper ID number and 1 as the lower ID number.) *The switch must be set to "9-14" for RTIP.*
