GE Medical Systems

Direction 2238944

Signa® 8 Channel Preamp Installation

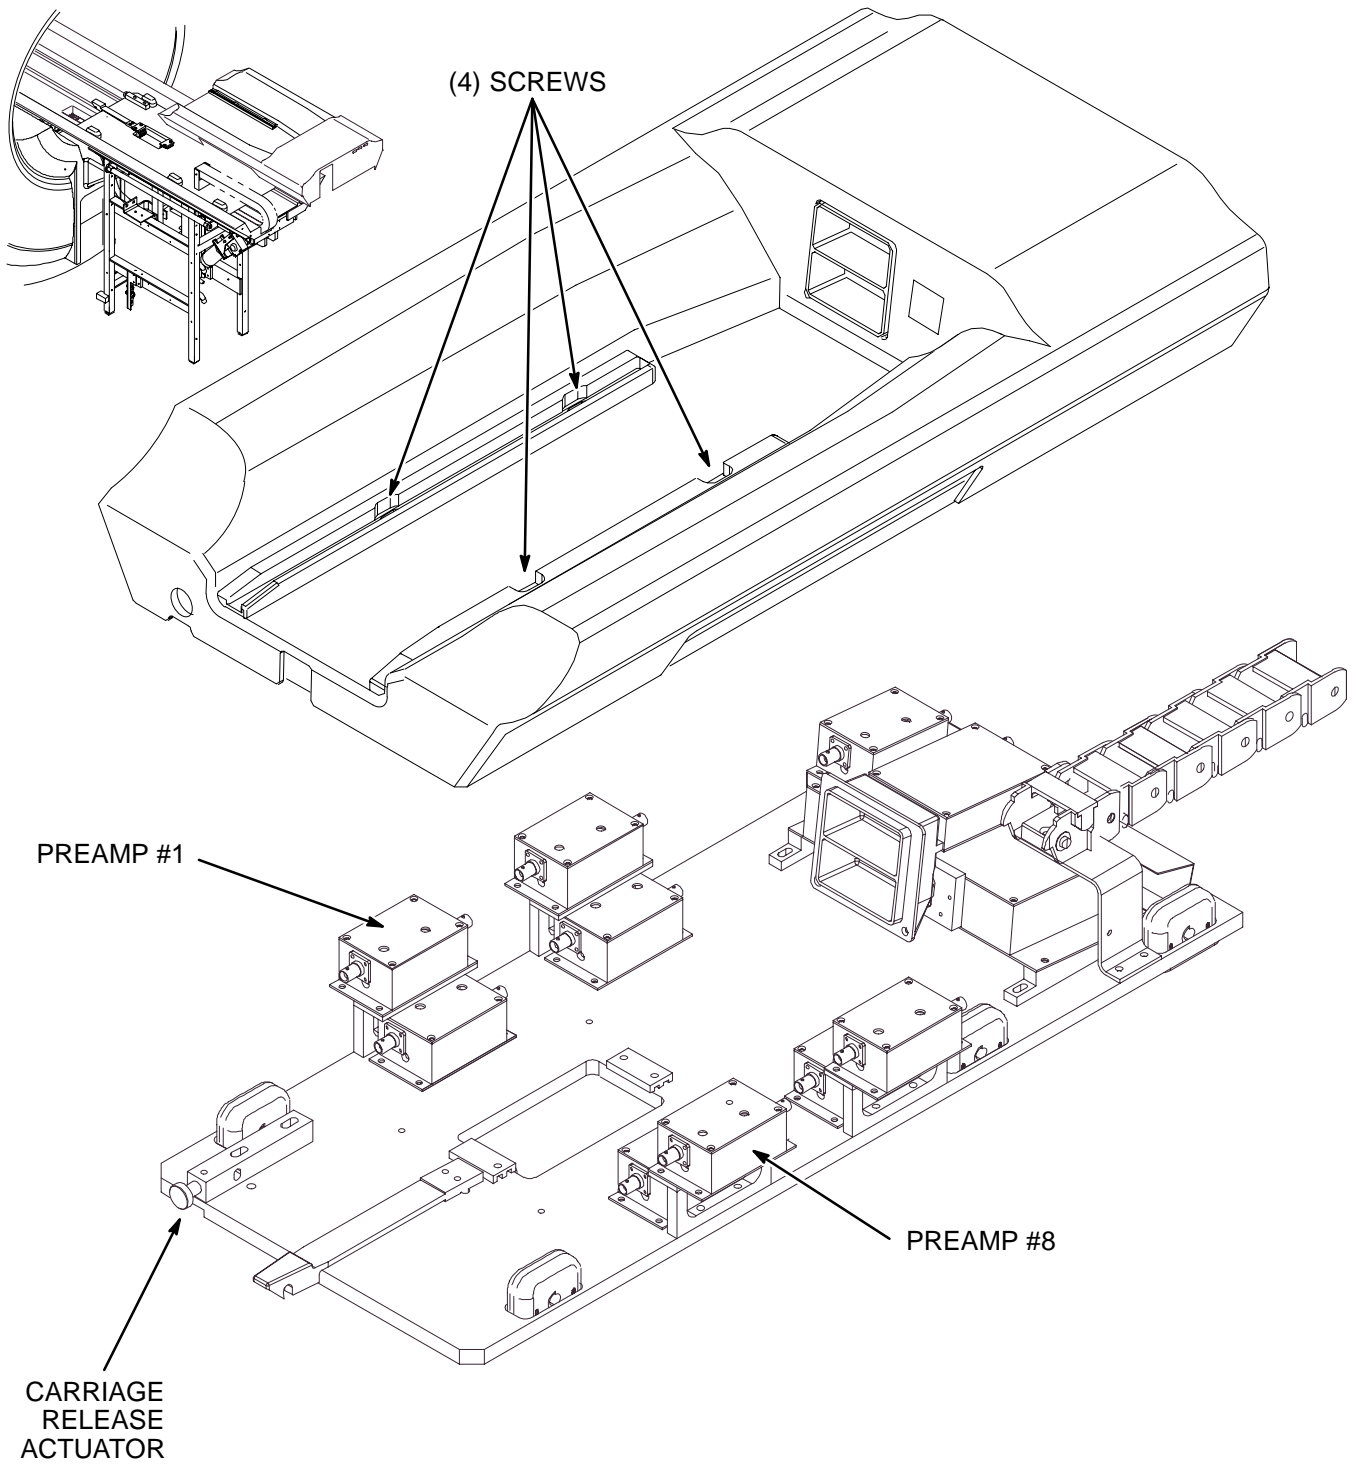
ILLUSTRATION 1-1

LOW PROFILE CARRIAGE COVER ASSEMBLY

4. Disconnect the cradle from the carriage to allow the cover to slip over the carriage release actuator in the next step.
5. Remove the 4 carriage cover screws and remove the cover by sliding the cover forward over the release actuator, lift, move back, and lift. See Illustration 1 -1.

6. Remove output cables for channel 1 and 8 from the preamp protect assembly.
7. Install preamps 1 and 8 in the locations specified on Illustration 1-1. Use the preamp support assembly hardware provided in this kit. Preamps 1 and 8 will be mounted using the same method as preamps 2 and 7 (refer to Illustration 1-2).

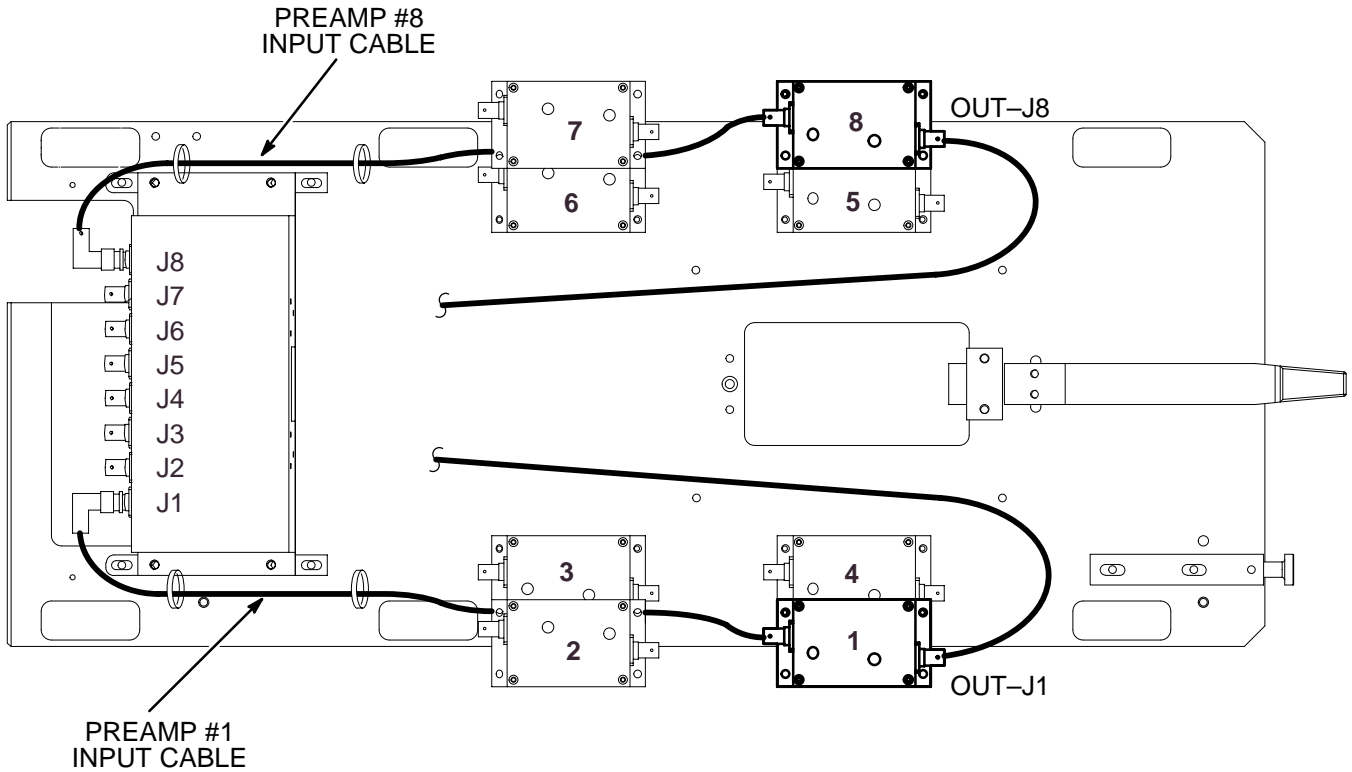
CABLE ROUTING
ILLUSTRATION 1–2

- 8. Connect preamp #1 input cable from preamp protect J1 to preamp 1 INPUT. See Illustration 1–2.
- 9. Connect preamp #8 input cable from preamp protect J8 to preamp 8 INPUT. See Illustration 1–2.
- 10. Connect output cable OUT–J1 to preamp 1 OUTPUT.
- 11. Connect output cable OUT–J8 to preamp 8 OUTPUT.

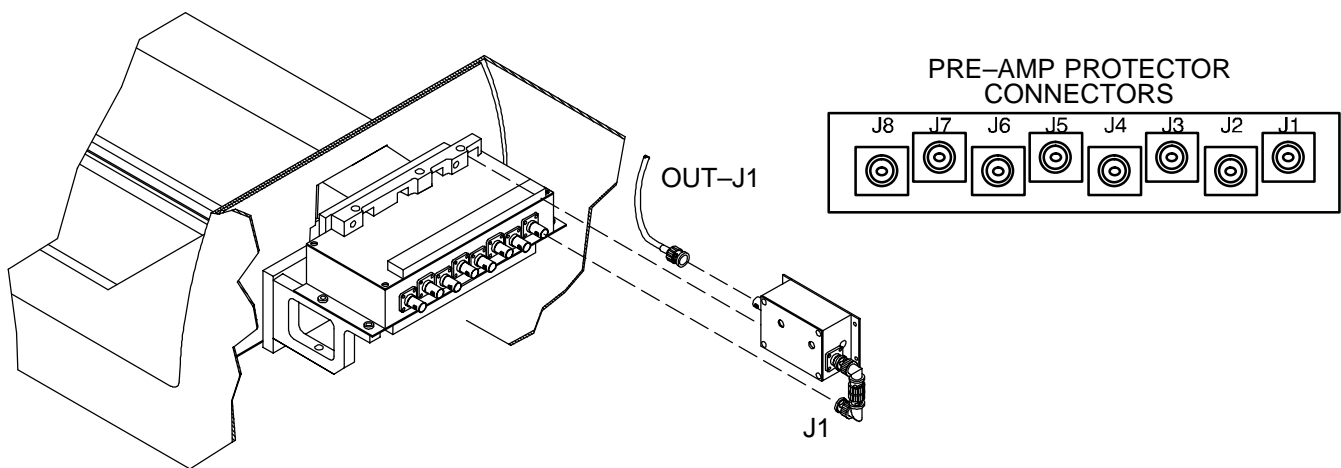
ILLUSTRATION 2–1

PREAMP INSTALLATION (CHANNEL 1)

1. Remove the power to the RF subsystem by turning off the appropriate circuit breaker. Follow lockout/tagout procedures (refer Service Methods CD; Safety; Section 6–OSHA Lockout/Tagout Requirements).
2. Verify that power is off by checking the fans and LEDs on both the RF amplifier and the System Support Module (SSM).
3. Move the patient pable all the way into the magnet to allow access to the head carriage assembly at the back of the magnet.
4. Remove access panel from rear of carriage cover.
5. Disconnect cable OUT–J1 and BNC right angle adapter from preamp protect J1.
6. Connect OUT–J1 cable to new preamp OUTPUT.
7. Insert new preamp into notch on preamp protect locating block. See illustration 2–1.
8. Connect two BNC right angle connectors and straight adapters to new preamp INPUT.
9. Connect the other end of the BNC connector assembly to preamp protect J1. See Illustration 2–1.

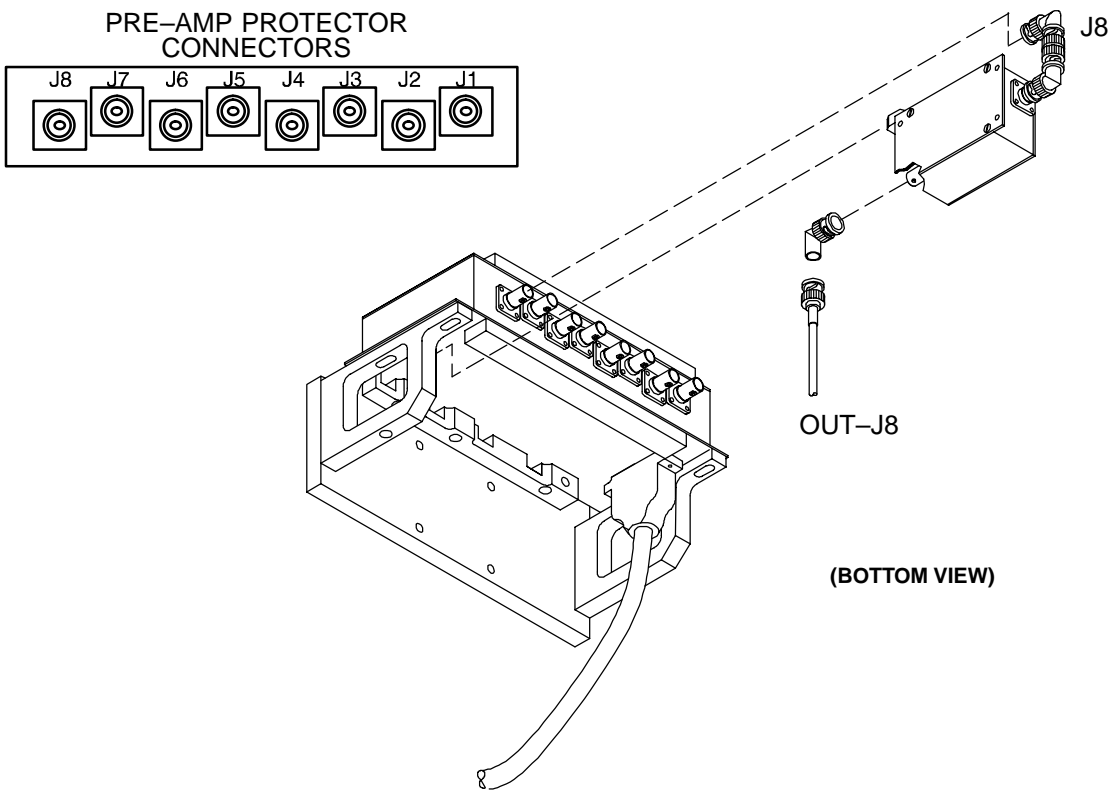
PREAMP INSTALLATION (CHANNEL 8)
ILLUSTRATION 2-2

10. Disconnect cable OUT-J8 and BNC right angle adapter from preamp protect J8.
11. Connect OUT-J8 cable to new preamp OUTPUT.
12. Insert new preamp into notch on preamp protect locating block. See illustration 2-2.
13. Connect two BNC right angle connectors and a straight adapter to new preamp INPUT.
14. Connect the other end of the BNC connector assembly to preamp protect J8. See Illustration 2-2.
