GE Medical Systems

**Direction 2282091
Revision 1**

Signa® Octane 9 GB Disk Drive Upgrade

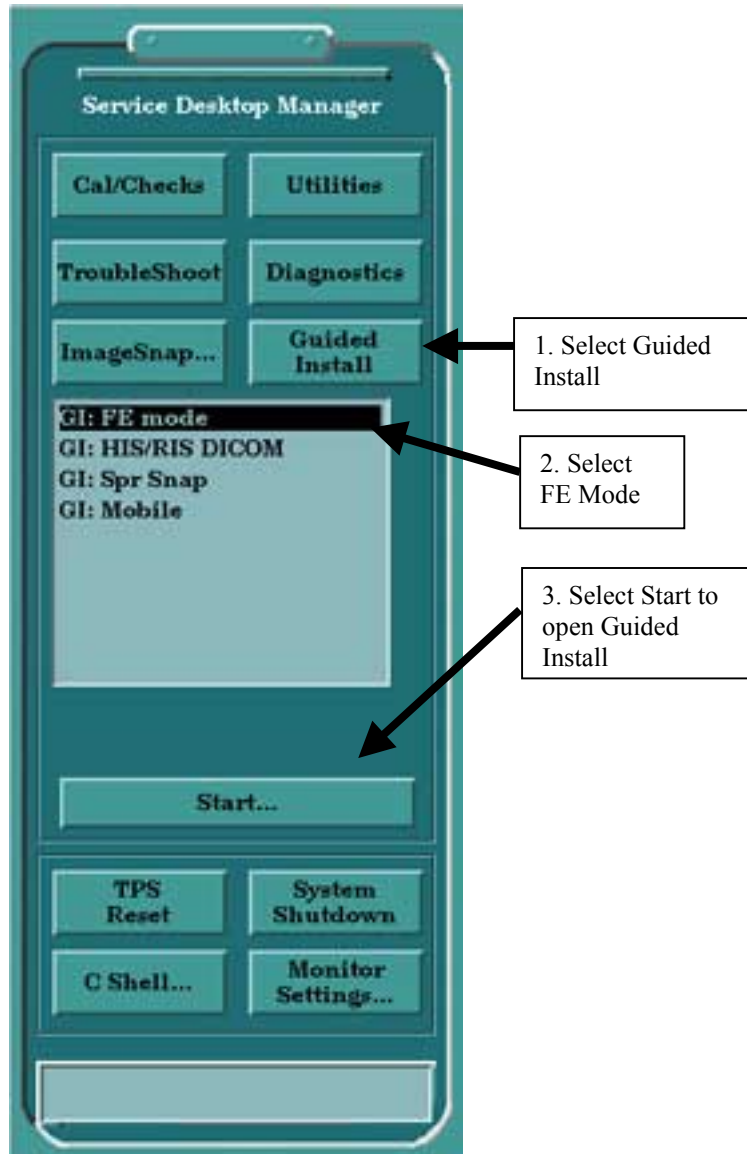
4. Reinstall the front bezel onto the computer.
5. Reapply power to the computer and monitor and boot the system to the Signa scanning level.
6. Go to the service Desktop and press the **[Guided Install]** button. Select FE mode and push **[Start]** to start the Install GUI. See Illustration 1-6.

ILLUSTRATION 1-6
STARTING GUIDED INSTALL

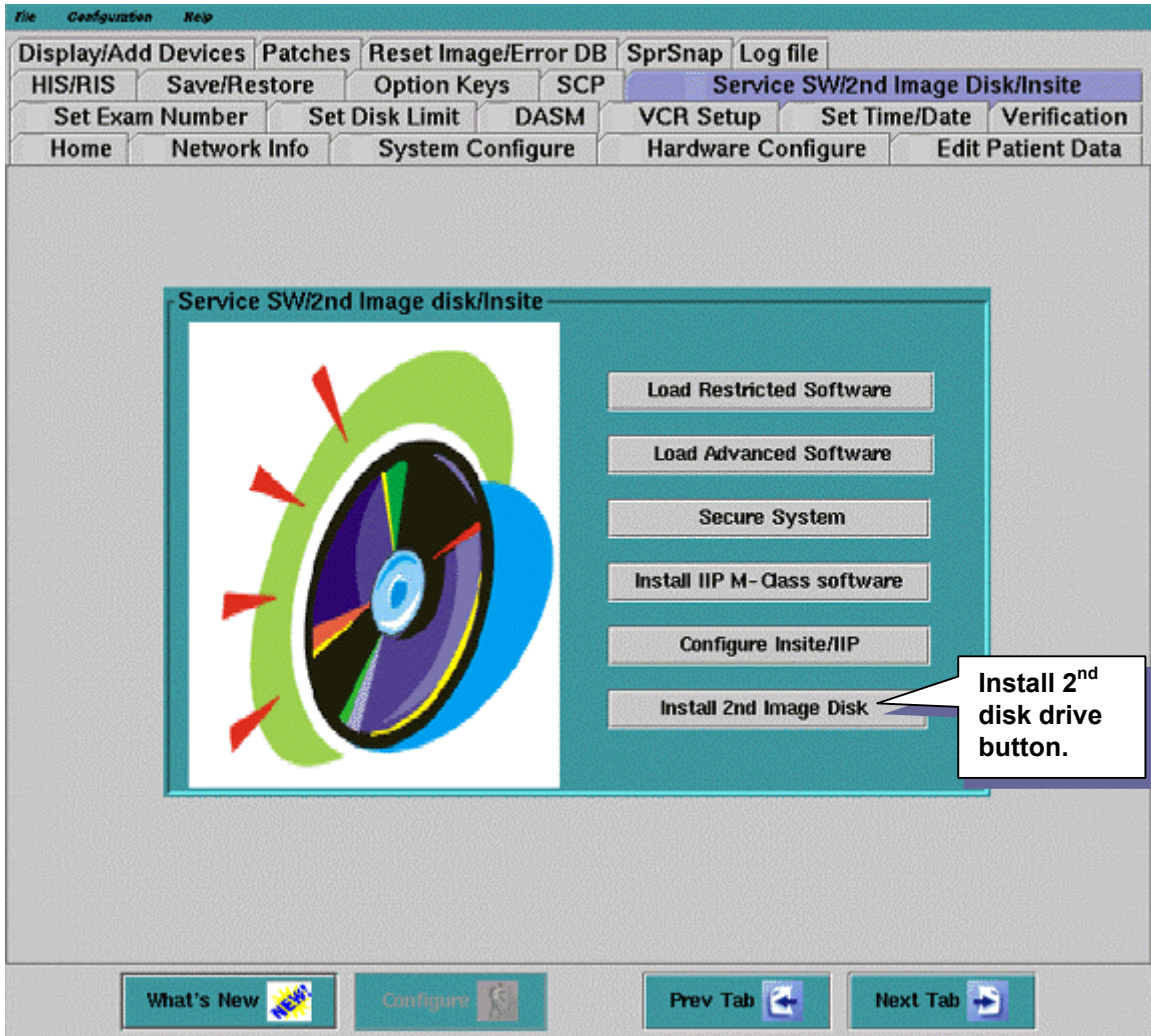
7. After the Guided Install has started, select the Service SW/2nd Image Disk/InSite tab. See Illustration 1-7.

ILLUSTRATION 1-7
SERVICE SW/2ND IMAGE DISK/INSITE TAB

8. Press the **[Install Second Image Disk]** button. The process takes less than two minutes.
9. Once completed, exit Guided Install and reboot Signa.
10. The upgrade is complete.
