*GE Medical Systems*

**Direction 2329893  
Revision 0**

## **APA2 Upgrade Installation**

This document describes the installation/replacement of the modified Preamp Protection, Driver-Splitter Box, and cables to the 1.5T system for the APA2. The configuration file will need to be updated. After this kit is installed, the system will have two additional new capabilities.

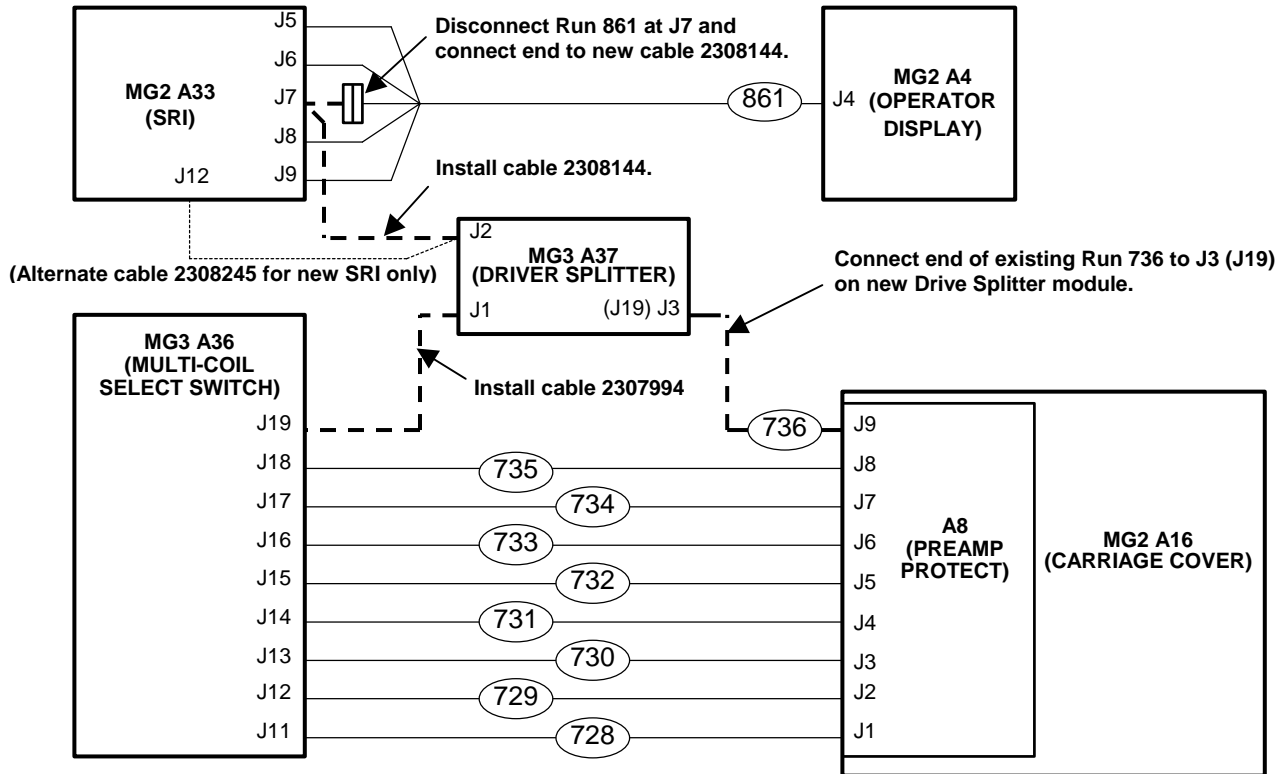
- 5) Locate SRI and disconnect cable at J7. Connect the intercept cable (2308144) to cable disconnected from J7 on SRI. Route 9 PIN sub-d cable to rear pedestal and connect to J2 of Driver Splitter box. Refer to illustration 2-5.

4) Connect cables to rear pedestal. See illustrations 2-3 or 2-4. Refer also to cable map in illustration 2-5.

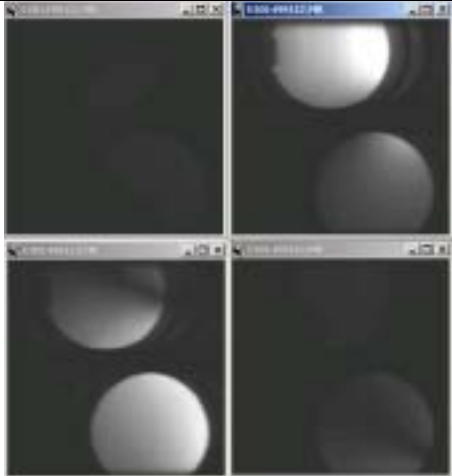
<p>Image set 1 (US)CTLTOP 18 FOV Should have only 2 active elements</p>

The following collection of image sets can be used to compare with your results to see if the APA is functionally correct:

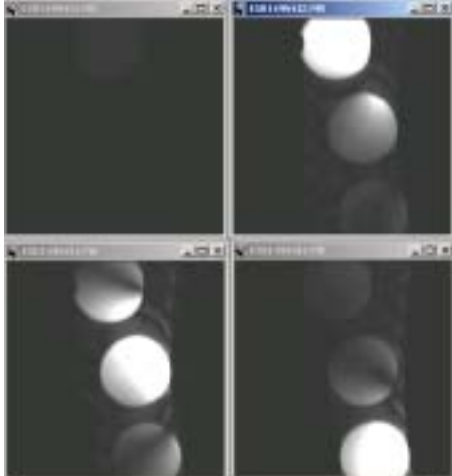
<p>Image set 2 (US)CTLTOP 36 FOV Should have only 3 active elements</p>

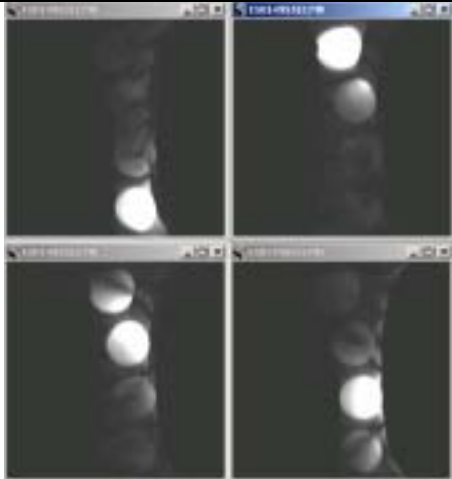
<p>Image set 3 (US)CTLTOP 48 FOV Should have 4 active elements</p>

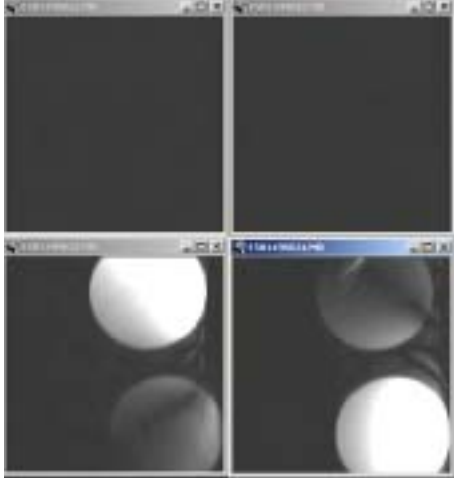
<p>Image set 4 (US)CTLMID 18 FOV Should have only 2 active elements</p>

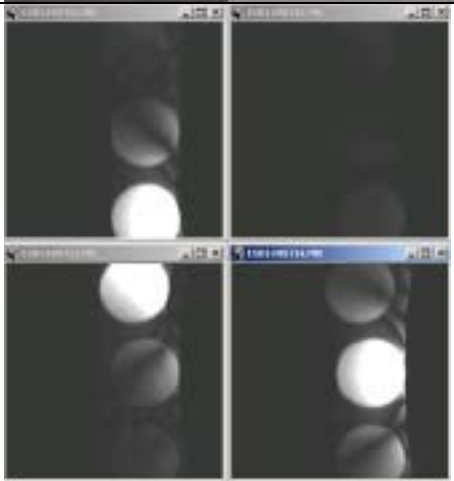
<p>Image set 5 (US)CTLMID 36 FOV Should have only 3 active elements</p>

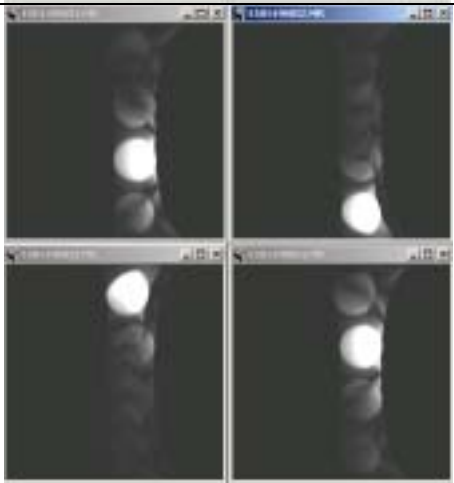
<p>Image set 6 (US)CTLMID 48 FOV Should have 4 active elements</p>

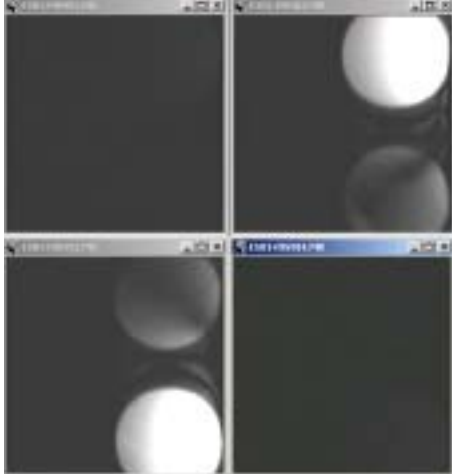
<p>Image set 7 (US)CTLBOT 18 FOV Should have only 2 active elements</p>

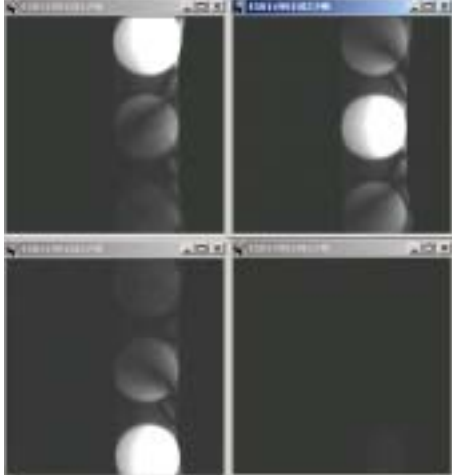
<p>Image set 8 (US)CTLBOT 36 FOV Should have only 3 active elements</p>
